MARINE INVESTIGATION REPORT M17C0035

Flooding

Fishing vessel *L.K.C*
Sept-Îles, Quebec, 45 nm E
21 April 2017

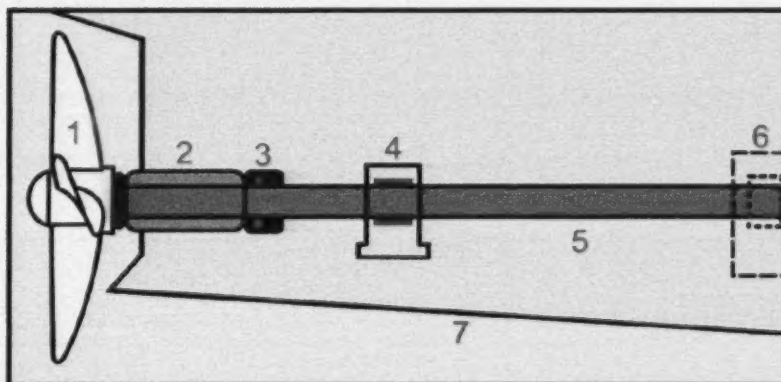
Figure 2. Propulsion shaft arrangement, showing 1: propeller; 2: water-cooled stern tube; 3: mechanical seal; 4: intermediate bearing; 5: propulsion shaft; 6: engine and gearbox; and 7: keel

It was concluded that the mechanical seal or its mounting was likely to have been damaged or altered when the bearing failed during the vessel's first voyage, but the type of damage that caused the stern tube seal to lose its watertightness during the occurrence voyage could not be determined.

The investigation found that the engine room of the *L.K.C* flooded due to a leaking mechanical seal at the stern tube. Although the exact cause of the seal's failure could not be determined, it is likely that the seal was damaged or altered when the intermediate bearing failed during the vessel's first voyage. By the time the crew became aware of the water ingress in the engine room, the water level had risen to a level that rendered the hydraulic and electric pumps inoperable.

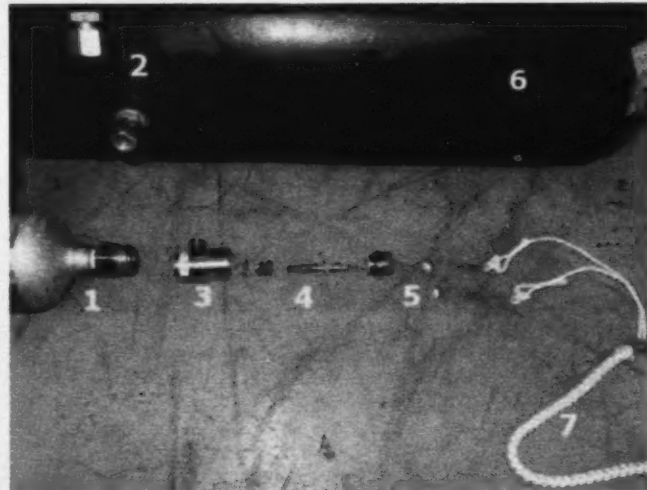
Figure 3. Life raft cylinder arrangement showing 1: cylinder head (contains membrane); 2: raft couplings for cylinders; 3: T-valve; 4: spring, firing pin; 5: arming nut, firing wire and fusible parts; 6: raft bottom chamber; 7: tug line (attached to painter)

The investigation therefore determined that the most likely cause of the life raft chambers' failure to inflate was insufficient gas content in the corresponding cylinders.

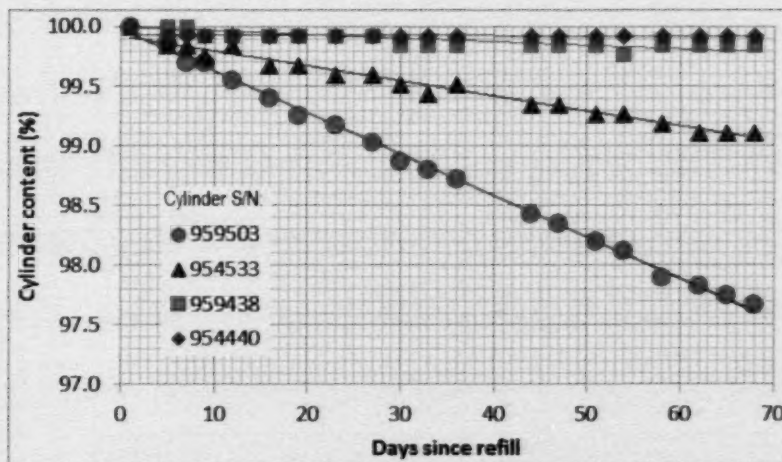
Figure 4. Graph showing the leakage over time of the 4 cylinders, shown in percentage value. According to the manufacturer's service manual, 2% was the maximum acceptable level of leakage.

Short leak tests conducted after filling and based on weight measurement or cylinder immersion, such as those practised at the service station or the subcontractor's cylinder- and gas-service facility, were found to be ineffective, because the time for detection of a leak was too short.
